# DAM SAFETY INSPECTION REPORT

## WOODLAND LAKE DAM

FILE NUMBER: 0610-009

INSPECTED: NOVEMBER 10, 2020

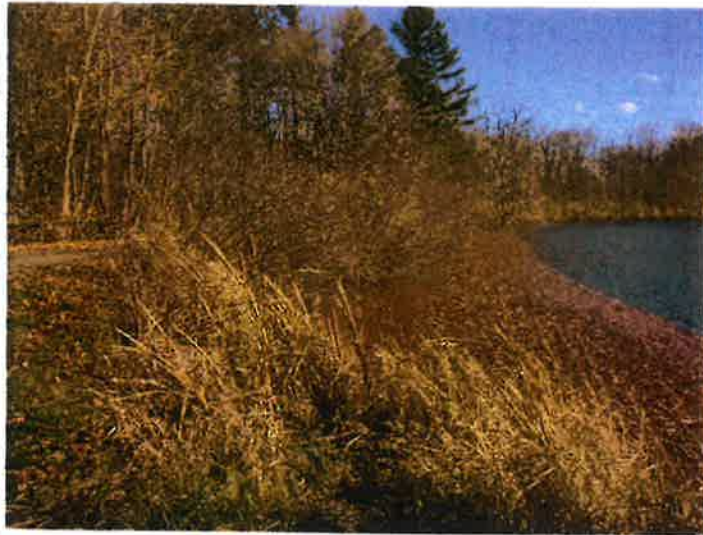
1. A view of the upstream slope from the left abutment. Note the trees, brush, tall vegetation, and cattails.

- Tall, dense trees and brush. Too dense to thoroughly inspect
- Erosion is occurring along the right side of the upstream slope
- Cattails along the left side by the abutment

1. Remove the trees and brush from the entire embankment, emergency spillway channel, and the principal spillway inlet and outlet. Repair the shoreline as needed. Seed all disturbed areas to establish a proper grass cover. Install rock riprap along the shoreline. See Discussion Item 1 and the "Trees and Brush" and "Upstream Slope Protection" fact sheets for additional information.
2. Remove the cattails from the upstream slope by the emergency spillway inlet and establish a proper vegetal cover. See the "Upstream Slope Protection" fact sheet for additional information.
3. Establish a proper vegetal cover on the wave berm. See the "Upstream Slope Protection" fact sheet for additional information.
4. Replace the trashrack at the inlet of the principal spillway. The current trashrack is inadequate. See the "Design and Maintenance of Trashracks" fact sheet for additional information.

5. After the trees, brush, and improper vegetation have been removed, monitor the upstream slope quarterly for erosion. If a problem develops, erosion protection may need to be installed. See the "Upstream Slope Protection" fact sheet for guidance in monitoring the condition of the embankment and for additional information.

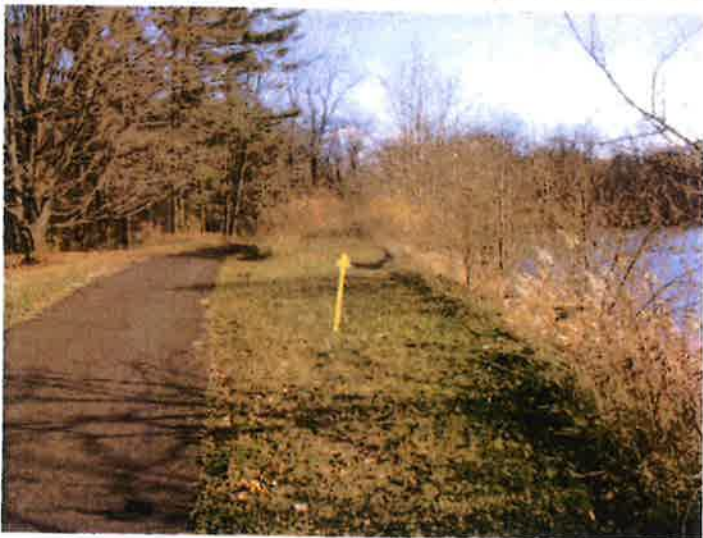
2. A view of the crest, upstream slope, and asphalt road leading down the downstream slope. The 10-foot-wide crest is indicated by the yellow arrow. This view is from the left abutment.

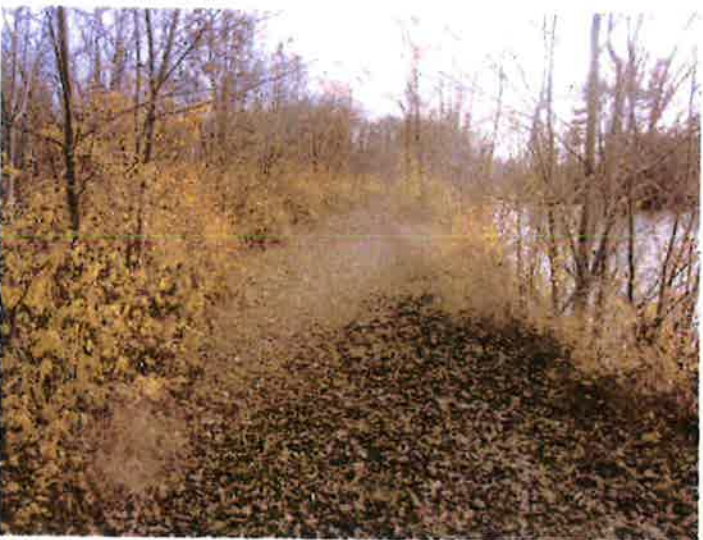
3. A view of the crest looking right.

- Good grass cover
- Mostly level, small undulations

6. Monitor the minor undulations along the crest quarterly for additional settlement or signs of embankment instability. See the "Embankment Instabilities" fact sheet for guidance in monitoring the stability of the embankment and for additional information. Please note that repairs may be needed if this problem worsens.

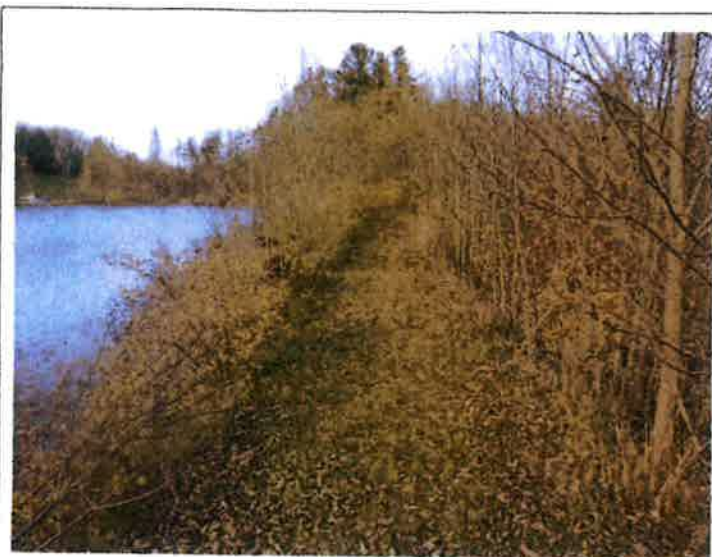
4. A view of the upstream slope from the right abutment. Note the trees, brush, and vegetation.

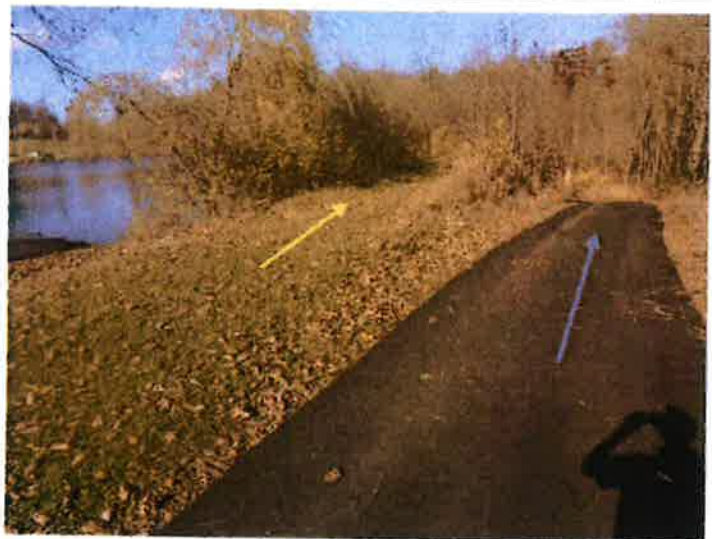
5. A view of the crest (yellow arrow) and downstream slope (blue arrow) from the right abutment.

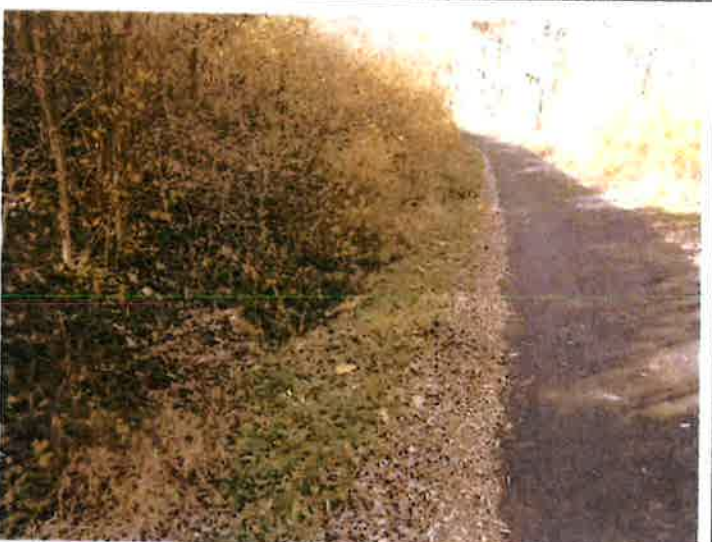
6. A view of the downstream slope looking left. Note that the dense trees and brush prevented a thorough investigation of the slope.

- There is a six-foot wide bench on the downstream slope. Along this bench is an asphalt walking/biking path. There is also a small ductile iron culvert under this path at the low point.
- Dense trees and brush prevented a thorough inspection

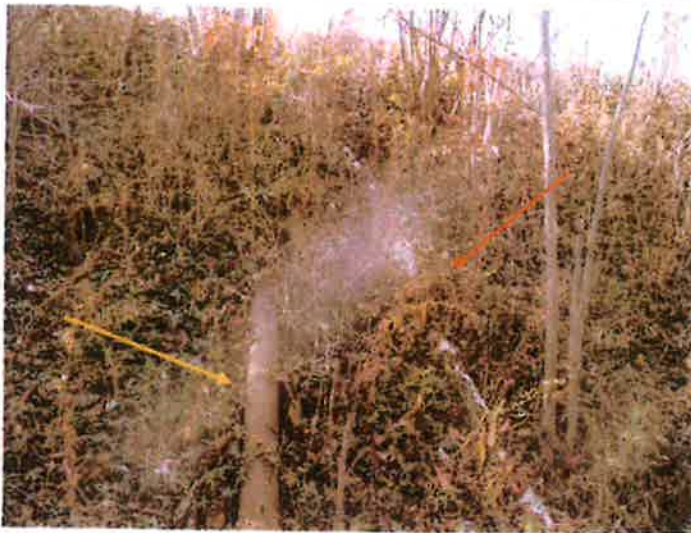
7. Another view of the downstream slope. Note the tall trees, new lake drain outlet pipe (red), and old lake drain outlet pipe (orange).

3. The pipe penetration that may be the original principal spillway must be investigated to ensure proper abandonment. If necessary, prepare plans and specifications for the proper abandonment of the original principal spillway. Regardless of the results of the investigation, the condition of the original principal spillway must be monitored quarterly. Also see Discussion Item 2.

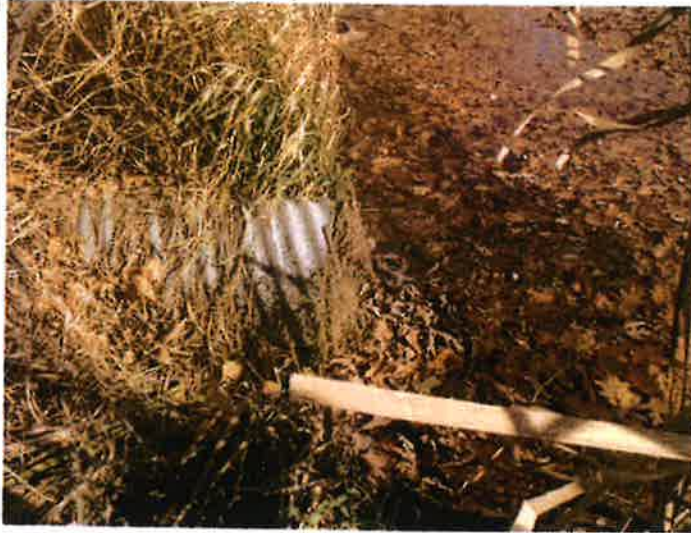
8. Principal spillway inlet pipe. Note the tall vegetation surrounding the inlet. The trash rack appears to be chicken wire staked on either side of the inlet pipe.

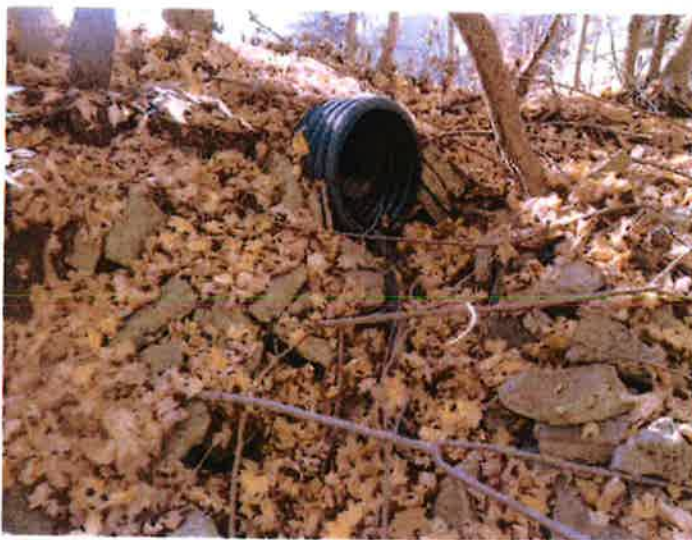
9. A view of the principal spillway outlet. Note that a short N-12 collar extension has been added to the end of the aluminum CMP.

7. Monitor the undermining of the principal spillway outlet quarterly for further undermining. See the "Spillway Conduit System Problems" and "Problems with Metal Materials" fact sheet for guidance in monitoring the spillway system and for additional information. Please note that repairs may be needed if this problem worsens.

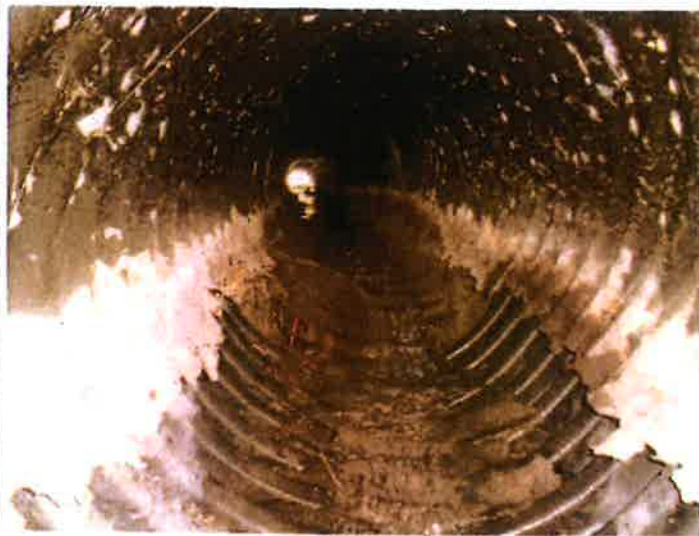
10. A view inside the aluminum CMP principal spillway outlet pipe. Note that the bottom of the pipe has completely rusted away, and the outlet is not aligned with the inlet. There also appears to be undermining for a couple feet back from the end of the corrugated plastic pipe extension.

- Tall vegetation & debris around the obstructed principal spillway inlet
- Unsatisfactory trash rack at inlet (chicken wire)
- CMP pipe is completely rusted through
- A shut two-foot N-12 collar extension has been added to the outlet
- Trees and brush surrounding outlet
- There is undermining at the outlet
- Could not locate outlet of old principal spillway mentioned in previous report. If not properly abandoned, it must be.

2. Every dam shall have a spillway system which will safely operate during the design flood without endangering the safety of the dam in accordance with OAC Rule 1501:21-13-03. The principal spillway system must be replaced. Prepare plans and specifications for replacement. The condition of the principal spillway system must be monitored quarterly until repairs can be made. This item should be completed in coordination with Item 1 above. See the "Spillway Conduit System Problems" and "Problems with Metal Materials" fact sheets for additional information.

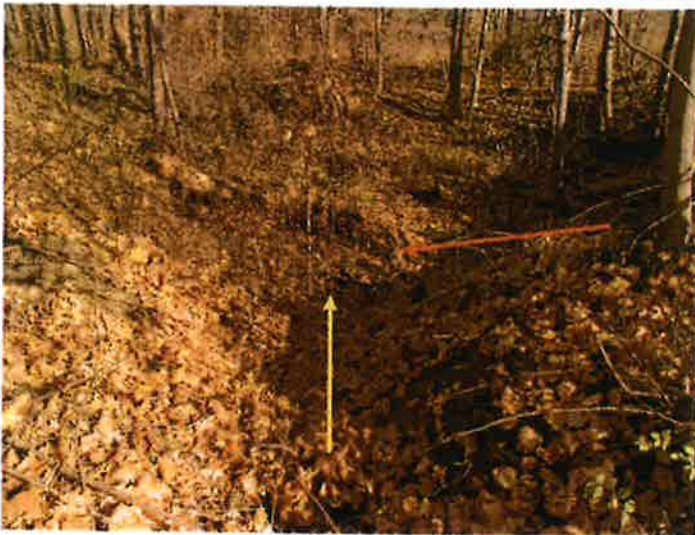
11. A view of the emergency spillway outlet channel. Flow direction indicated by the yellow arrow. The red arrow indicates approximately where the principal spillway outlet flows.

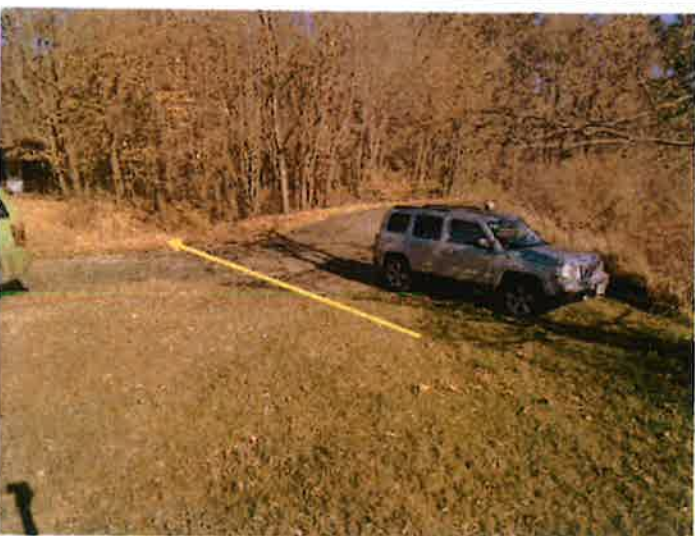
12. A view of the emergency spillway inlet, looking downstream. The yellow arrow indicates flow direction.

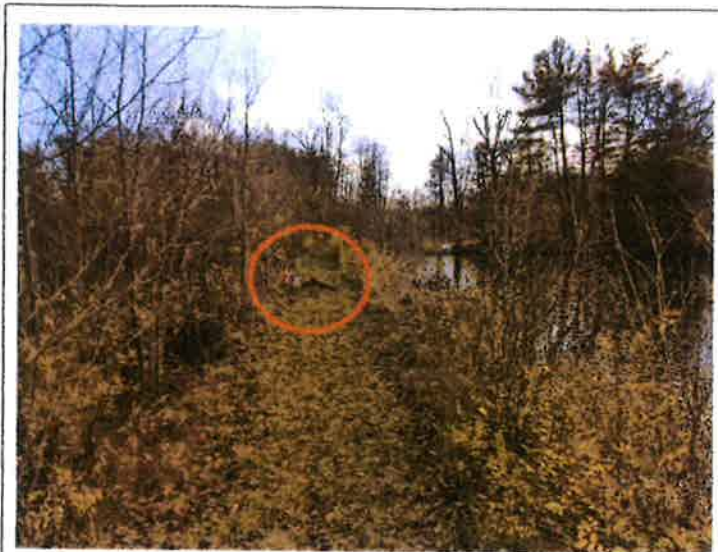
13. A view of the lake drain siphon valve located midway on the crest (circled in red).

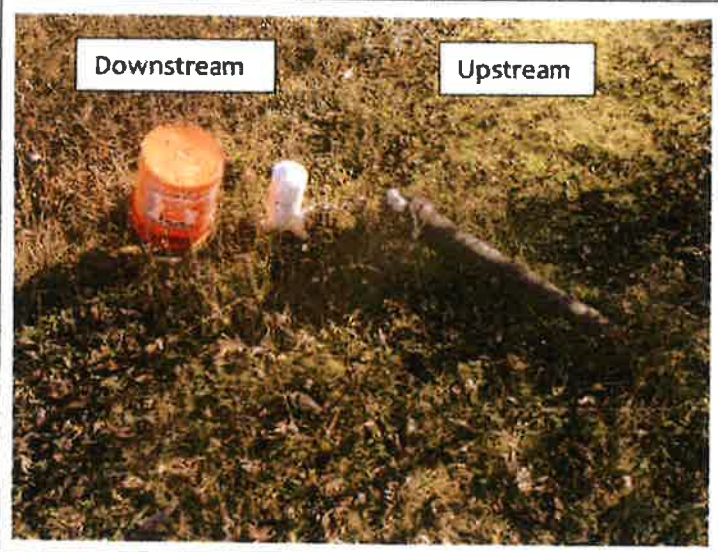
14. A close-up view of the lake drain siphon valve. Note that the siphon system consists of ductile iron pipe on the upstream side of the crest and PVC downstream of the crest. The connection is made by a Fernco flexible coupling.
